112 EDMUND PLACE + 2827 JOHN R  
HISTORIC DISTRICT COMMISSION : 2018.06.13

OOMBRA  
ARCHITECTS

# 112 EDMUND PLACE + 2827 JOHN R

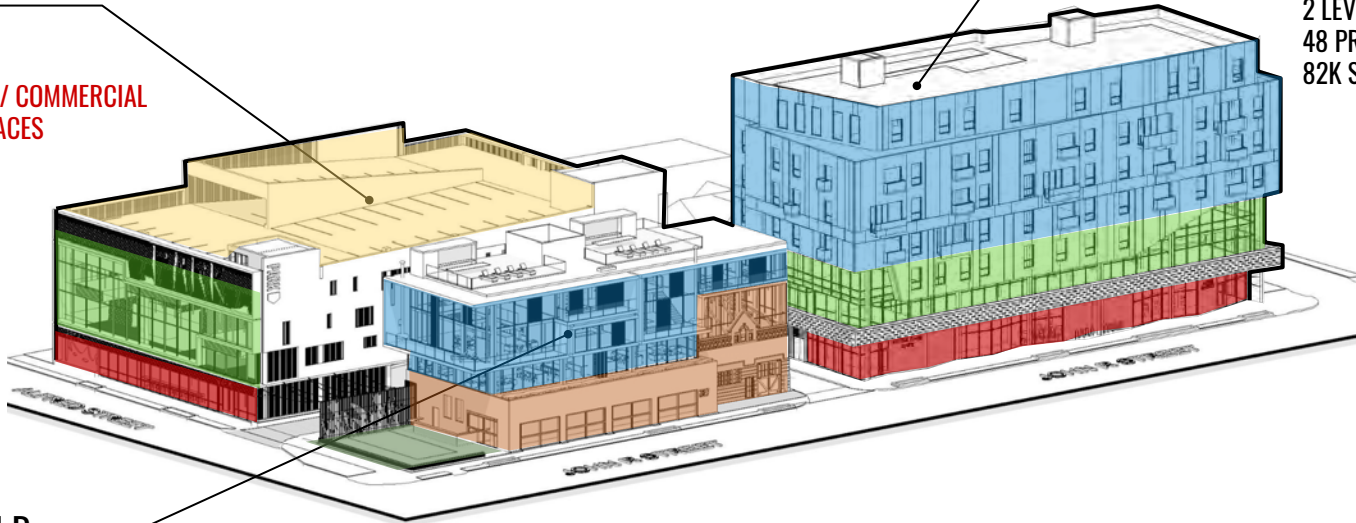
## PROJECT OVERVIEW : 3/15/2018 CPC

7 STORIES  
32 RES UNITS  
2 LEVELS OF COMMERCIAL USE  
48 PRKG SPACES  
82K SF

5 STORIES  
4K SF RETAIL / COMMERCIAL  
155 PRKG SPACES  
75K SF

4 STORIES  
RESTAURANT/LOUNGE  
5 LUXURY UNITS  
20K SF  
OUTDOOR DINING

37 RESIDENTIAL UNITS  
2 LEVELS OF COMMERCIAL USE (20K SF)  
9K SF RETAIL  
1 RESTAURANT AND LOUNGE  
203 PRKG SPACES  
177K GSF

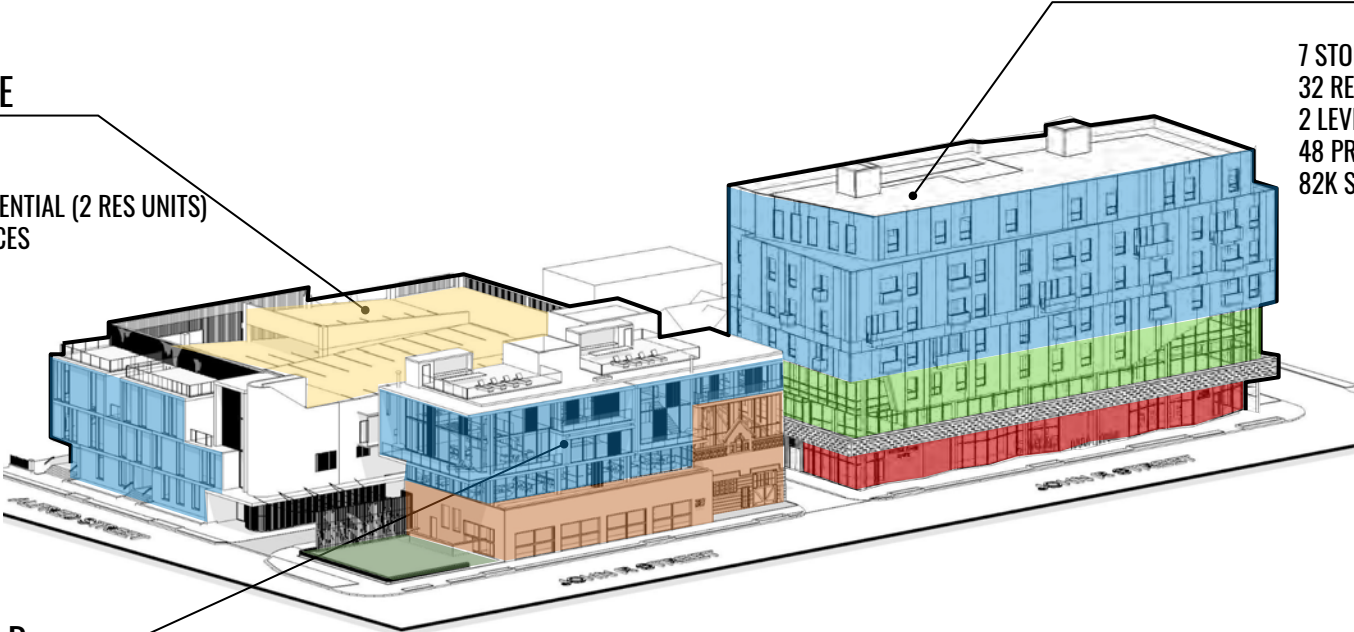
# PROJECT OVERVIEW : CURRENT DESIGN

7 STORIES  
32 RES UNITS  
2 LEVELS OF COMMERCIAL USE  
48 PRKG SPACES  
82K SF

4 STORIES  
4.5K SF RESIDENTIAL (2 RES UNITS)  
92 PRKG SPACES  
62K SF

4 STORIES  
RESTAURANT/LOUNGE  
5 LUXURY UNITS  
20K SF  
OUTDOOR DINING

- 39 RESIDENTIAL UNITS (37 CONDO UNITS, 2 TOWNHOMES) ~~37 RES UNITS~~
- 2 LEVELS OF COMMERCIAL USE (20K SF)
- 5K SF RETAIL ~~9K SF RETAIL~~
- 1 RESTAURANT AND LOUNGE
- 140 PRKG SPACES (62 RESERVED FOR RES USE - 80 NON RES USE) ~~203~~
- 164K GSF ~~177 GSF~~

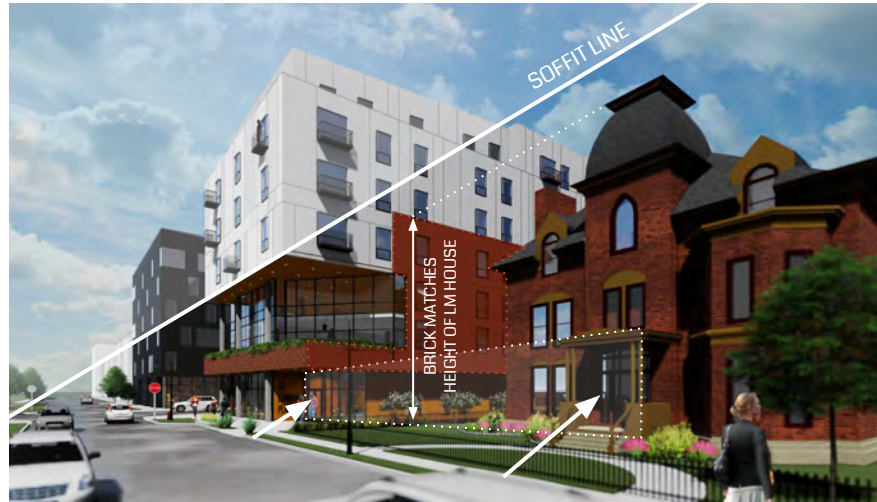
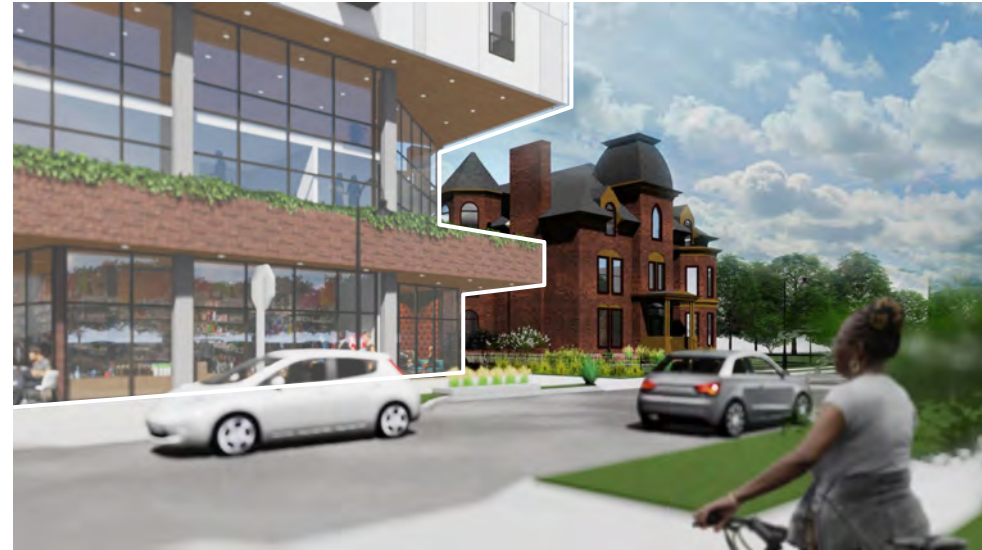
# 112 EDMUND PLACE : DEFERENCE TO LUCIEN MOORE HOME

- **RAISED SOFFIT LINE** FOR VIEWS OF THE LUCIEN MOORE HOME FROM VANTAGE POINTS ALONG EDMUND PLACE AND JOHN R STREET
- **SET-BACK ENTRY** FOR ALIGNMENT WITH OTHER RESIDENTIAL ENTRIES ALONG EDMUND PLACE
- **BRICK FACADE** PROVIDES A BACKDROP TO THE LUCIEN MOORE HOME WITH A HEIGHT MATCHING THE ELEVATION OF THE MANSION, PROVIDING SCALE AND CONSISTENCY OF MATERIAL
- **ANGLED STOREFRONT GLASS BACK** AT LOWER LEVELS FOR TO ALLOW FOR VIEWS TO AND FROM THE LUCIEN MOORE HOME TO CORNER

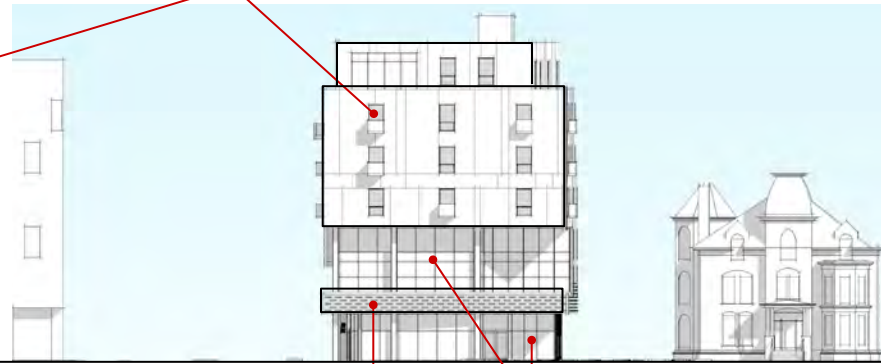
**METAL MESH GUARD**  
Dark Bronze

**FIBER CEMENT PANEL**  
Equitone, Tectiva, TE00

**WINDOWS**  
Wausau InVent, Dark Bronze

**BRICK**  
Red, Textured

**FIBER CEMENT PANEL**  
Equitone, Tectiva, TE90

**BRICK**  
Red, Patterned

**STOREFRONT**  
Dark Bronze

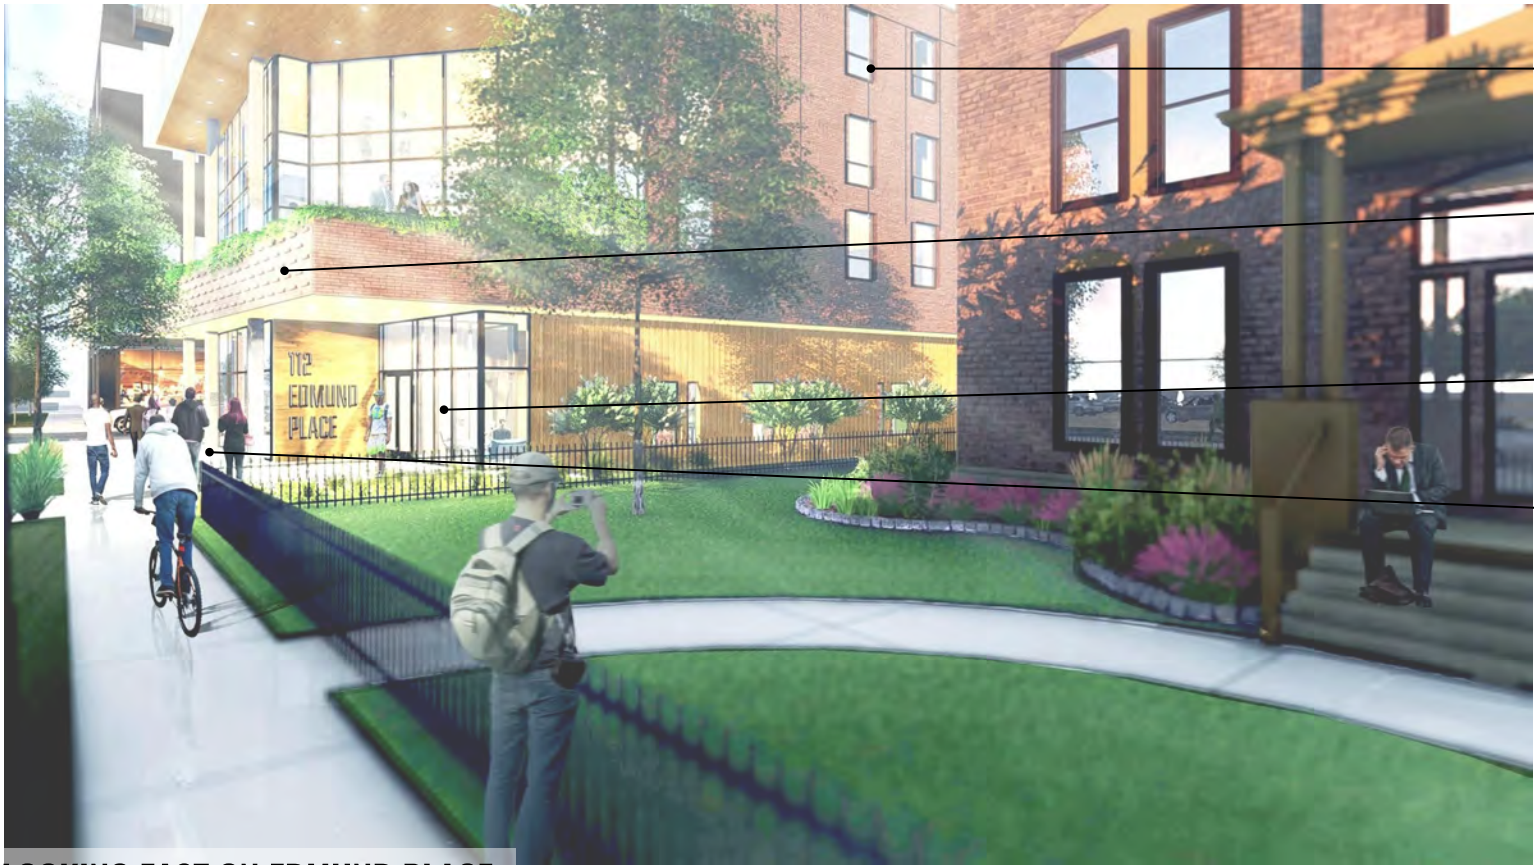
LOOKING EAST ON EDMUND PLACE

3 **PROPORTION OF OPENINGS WITHIN THE FACADE**  
"Areas of void generally constitute between 15 and 35 percent . . . generally taller than wide"

7 **RELATIONSHIP OF MATERIALS**  
"All other buildings more than 4 stories are located between Woodward and John R"

6 **RHYTHM OF ENTRANCE AND OR PORCH PROJECTIONS**  
"Most buildings have or had a porch or entrance projection"

17 **RHYTHM OF BUILDING SETBACKS**  
"Buildings on the North-South streets generally have little or no setback"

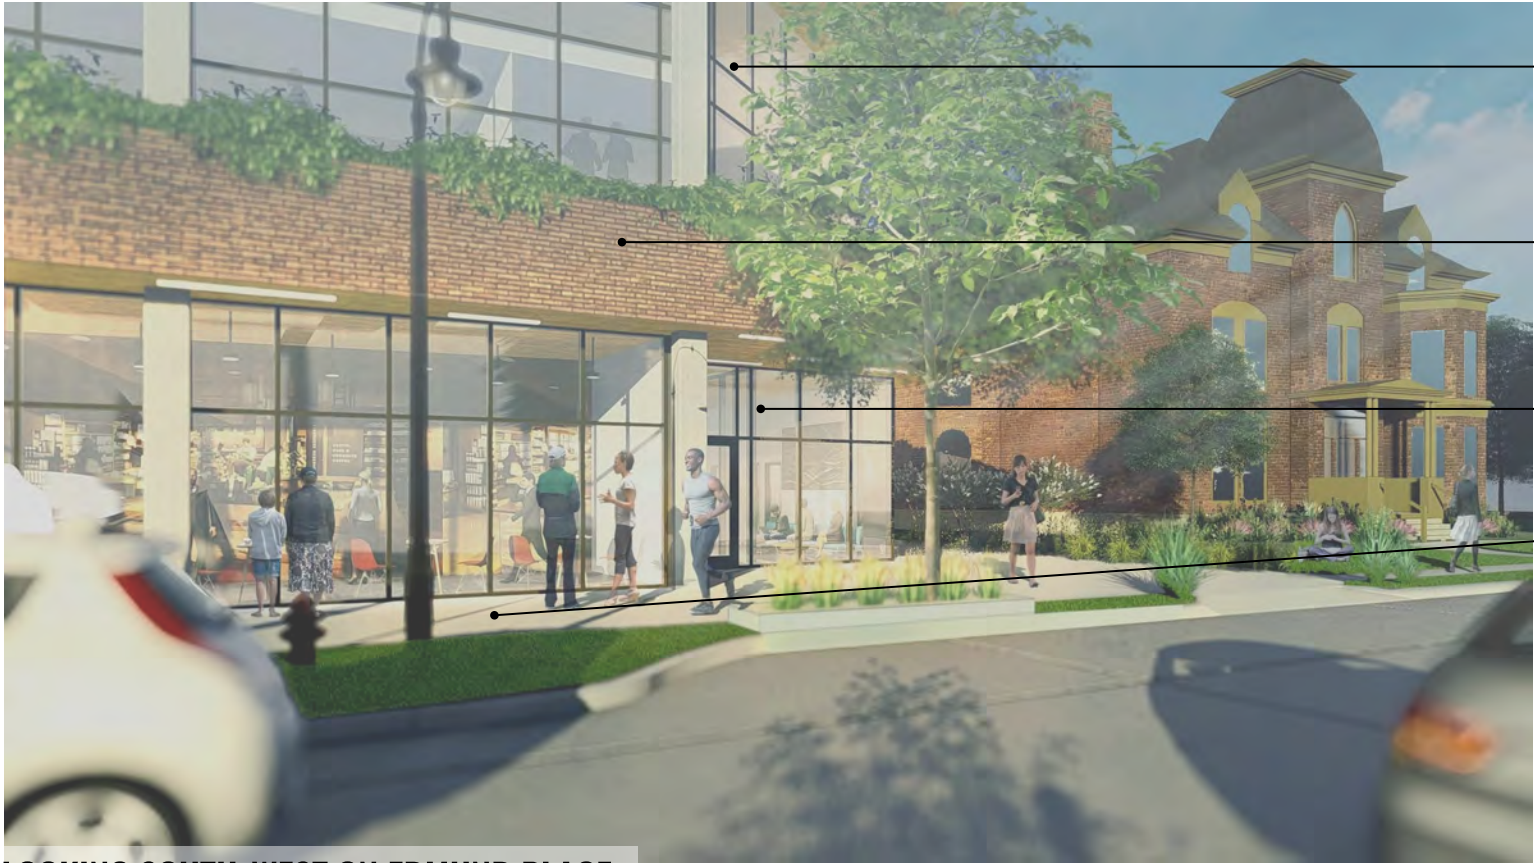
LOOKING SOUTH-WEST ON EDMUND PLACE

- 20 **ORIENTATION, VISTAS, OVERVIEWS**  
*"Houses are generally oriented to the East-West streets, while apartments and commercial structures are more often oriented to the north-south streets."*
- 7 **RELATIONSHIP OF MATERIALS**  
*"All other buildings more than 4 stories are located between Woodward and John R"*
- 6 **RHYTHM OF ENTRANCE AND OR PORCH PROJECTIONS**  
*"Most buildings have or had a porch or entrance projection"*
- 17 **RHYTHM OF BUILDING SETBACKS**  
*"Buildings on the North-South streets generally have little or no setback"*

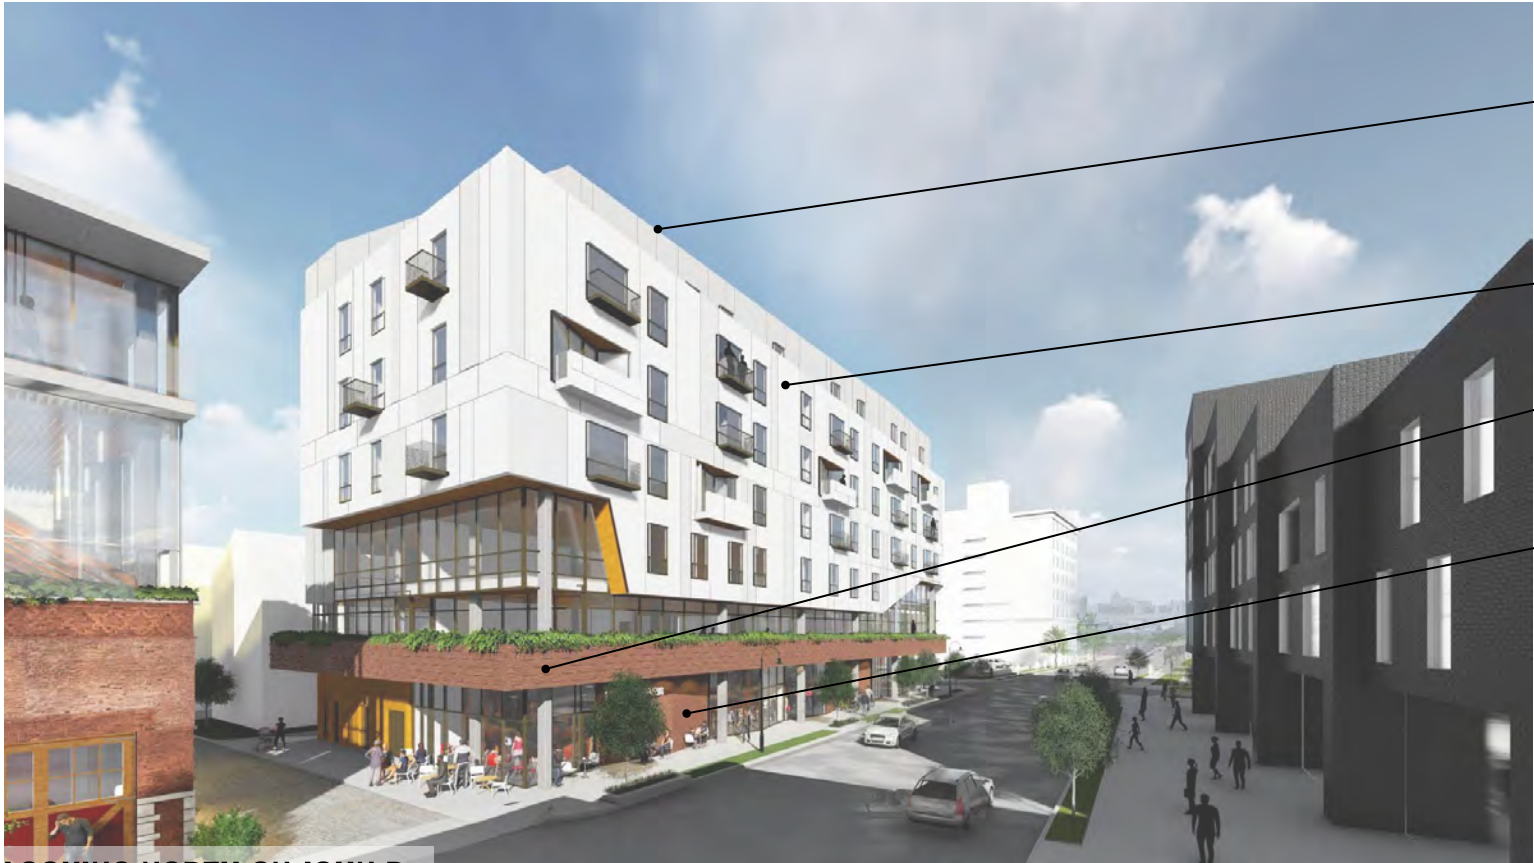
LOOKING NORTH ON JOHN R

1 **HEIGHT**  
*"All other buildings more than 4 stories are located between Woodward and John R, and generally on or adjacent to buildings on those streets."*

21 **SYMMETRIC OR ASYMMETRIC APPEARANCE**  
*"Asymmetric but balanced compositions are common"*

10 **RELATIONSHIP OF ARCHITECTURAL DETAIL**  
*"Elaborate detail in wood, stone or sheet metal . . . later buildings are simpler but include less elaborate detail"*

9 **RELATIONSHIP OF COLORS**  
*"Brick red predominates, both in the form of natural colors and painted brick . . . other natural brick and stone colors are also present."*

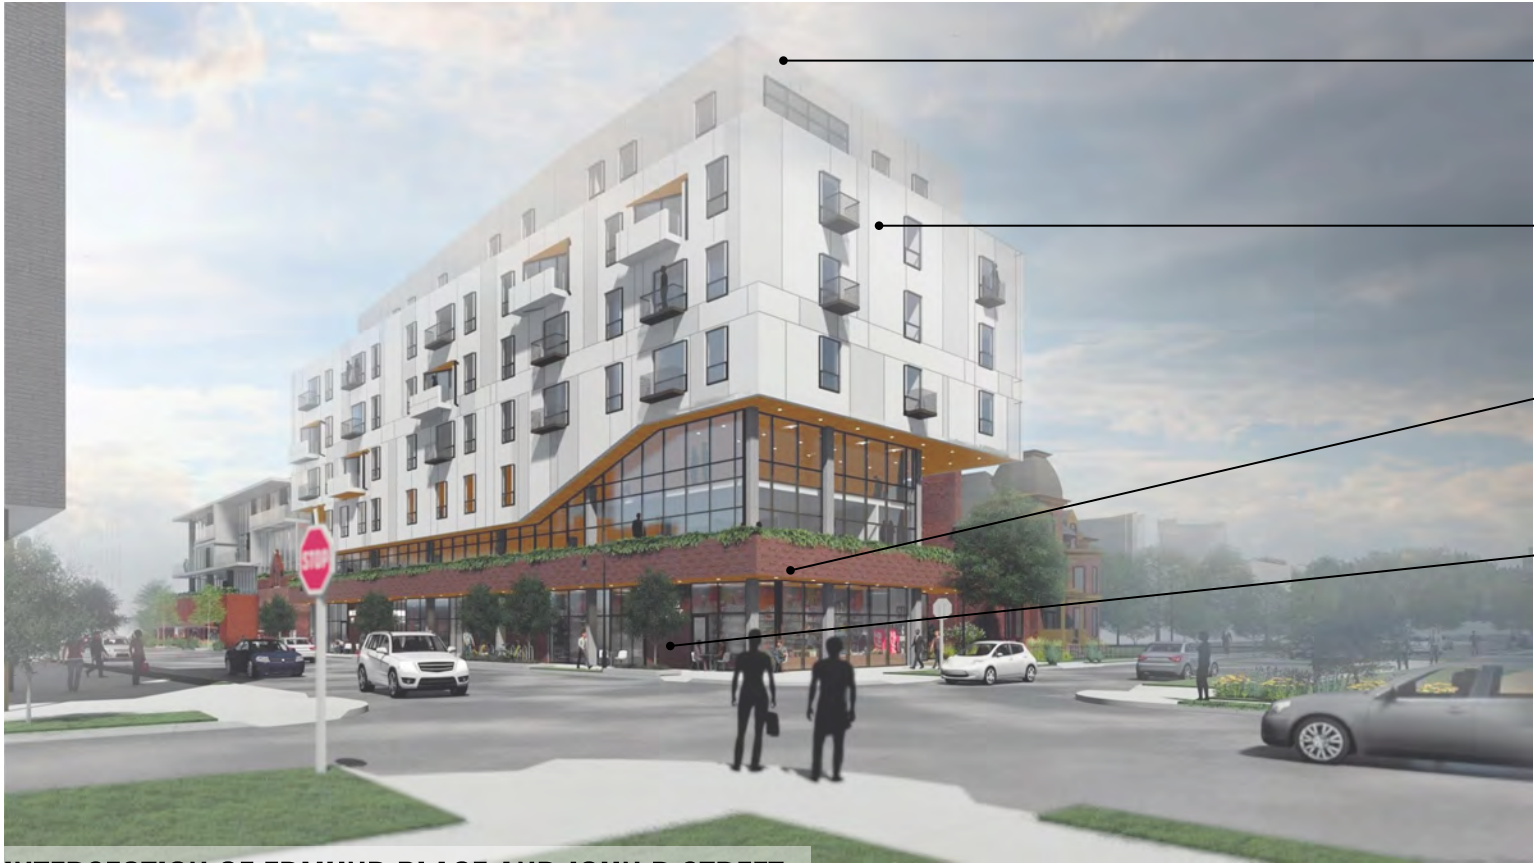
INTERSECTION OF EDMUND PLACE AND JOHN R STREET

"All other buildings more than 4 stories are located between Woodward and John R, and generally on or adjacent to buildings on those streets."

"Later apartments are large in scale with simple but large elements near the ground and repetitive window openings above"

"The most common relationship of textures in the district is the low relief pattern of mortar joints in the brick contrasted to smoother or rougher surfaces."

"Where buildings are continuous, a wall of continuity is created."

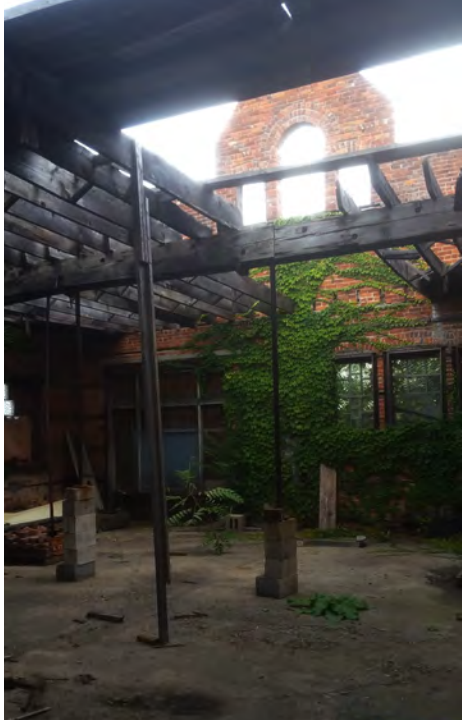
INTERIOR LOOKING EAST

CONDITION OF EXISTING MASONRY SHELL  
*CARRIAGE HOUSE*

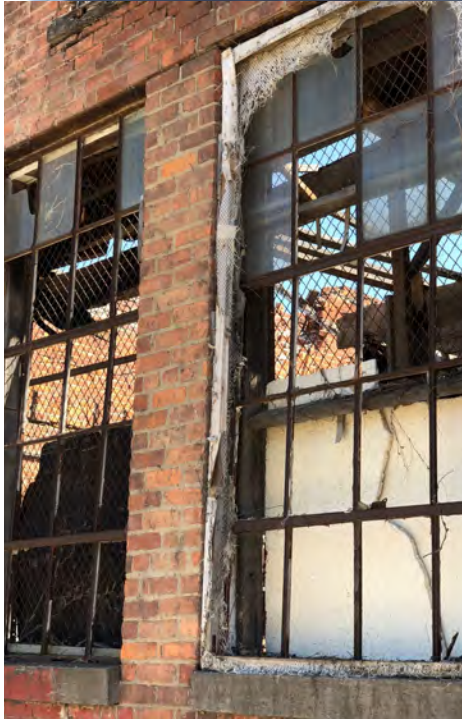
CARRIAGE HOUSE NORTH WINDOWS

CONDITION OF EXISTING MASONRY SHELL  
*WINDOW OPENINGS*

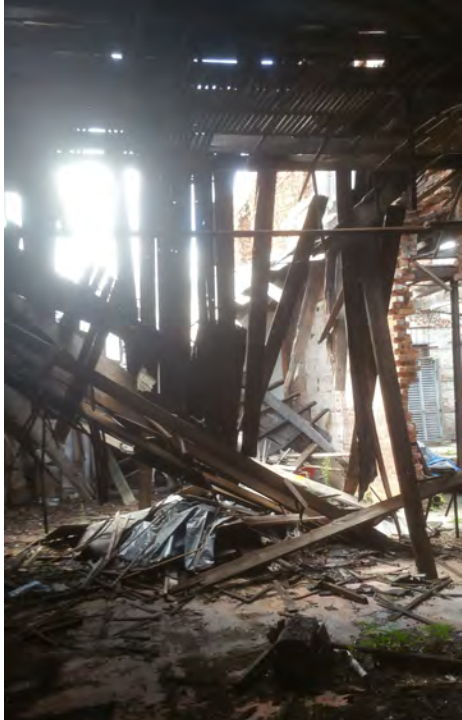
INTERIOR LOOKING EAST

CONDITION OF EXISTING MASONRY SHELL  
*1 STORY BRICK*

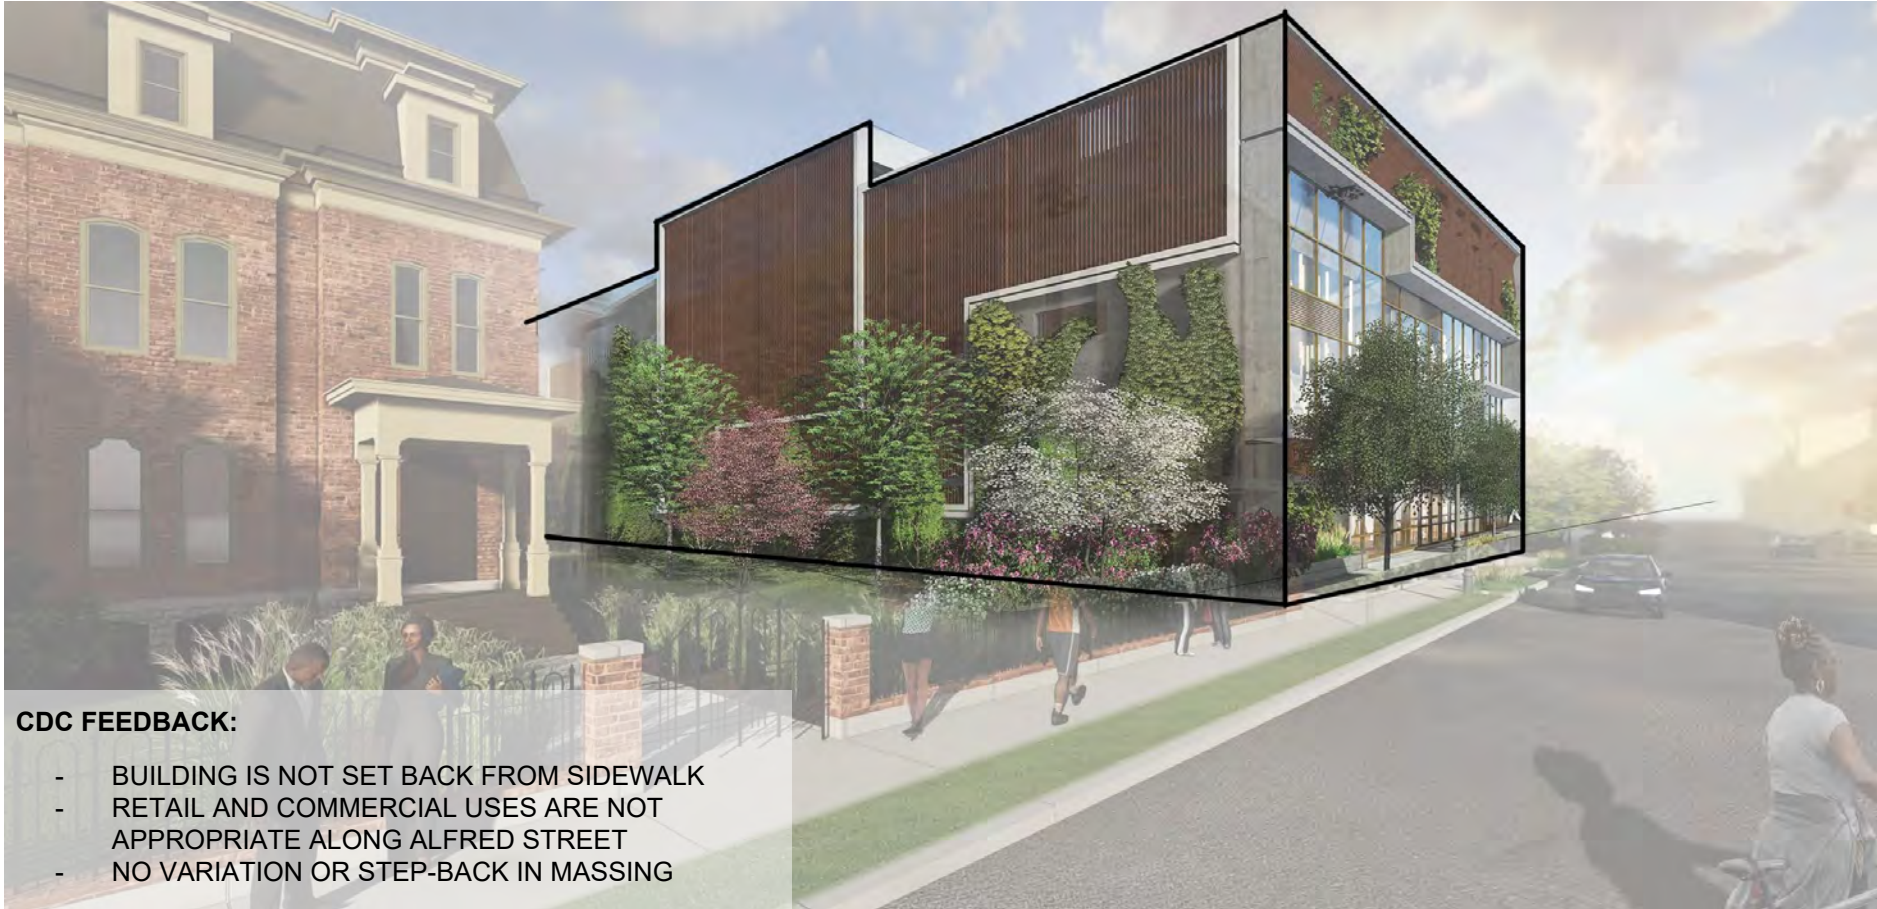
112 EDMUND PLACE + 2827 JOHN R  
**2827 JOHN R STREET : PREVIOUS MASSING**

**CDC FEEDBACK:**

- BUILDING IS NOT SET BACK FROM SIDEWALK
- RETAIL AND COMMERCIAL USES ARE NOT APPROPRIATE ALONG ALFRED STREET
- NO VARIATION OR STEP-BACK IN MASSING

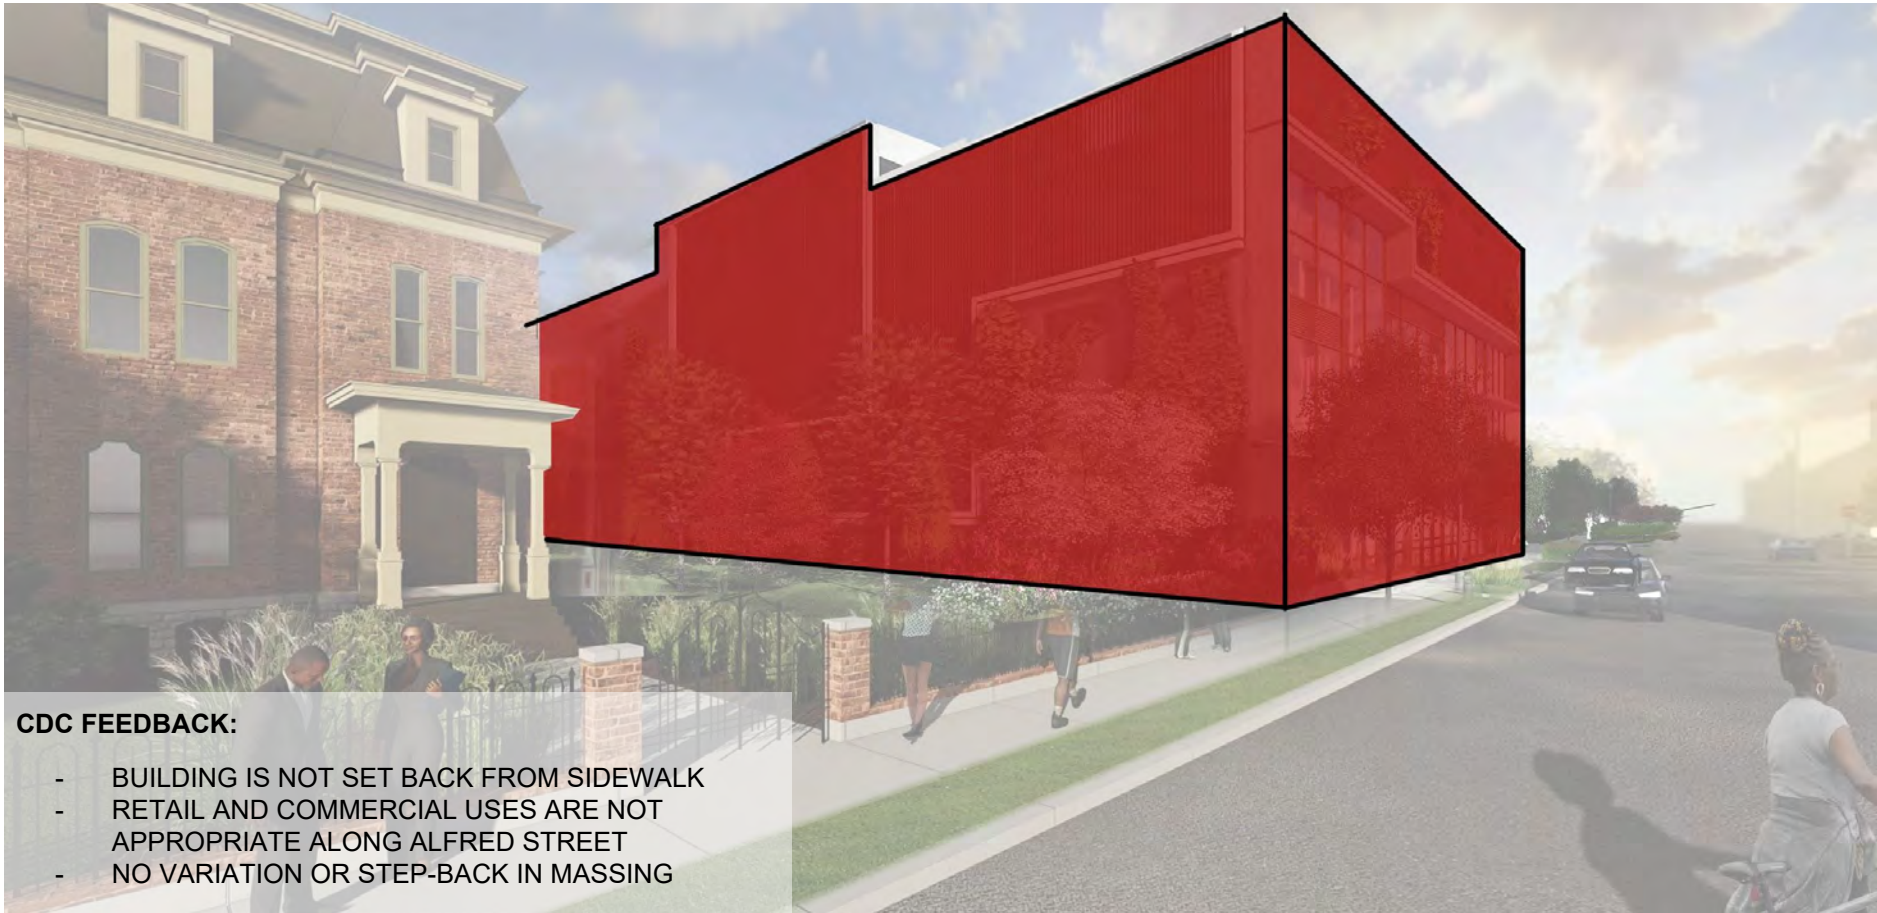
112 EDMUND PLACE + 2827 JOHN R  
**2827 JOHN R STREET : PREVIOUS MASSING**

**CDC FEEDBACK:**

- BUILDING IS NOT SET BACK FROM SIDEWALK
- RETAIL AND COMMERCIAL USES ARE NOT APPROPRIATE ALONG ALFRED STREET
- NO VARIATION OR STEP-BACK IN MASSING
